Pressure Mottling

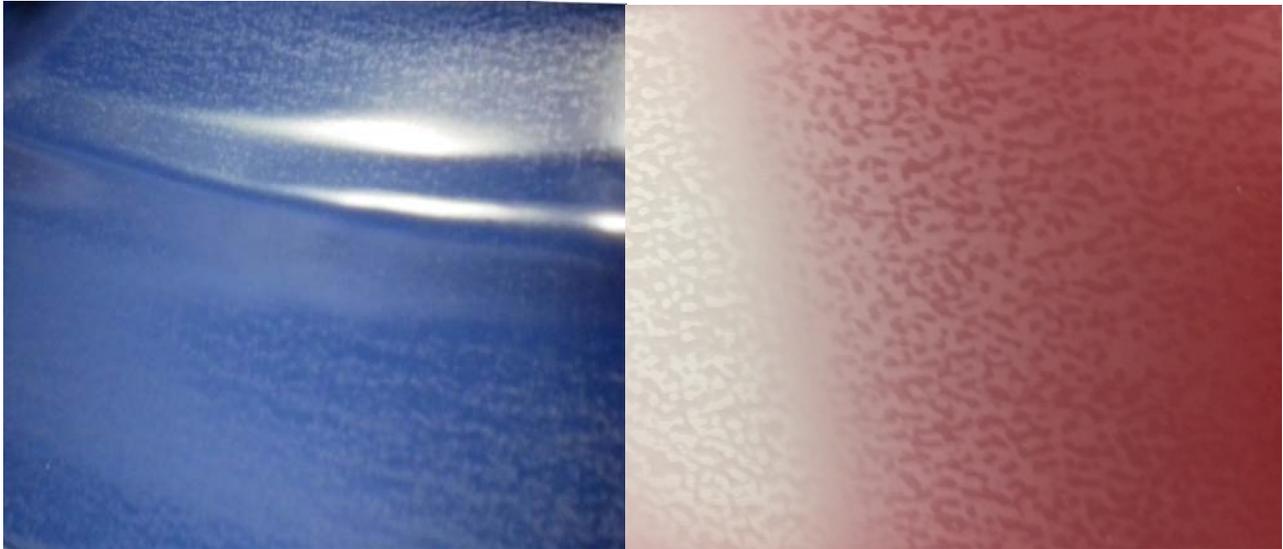
Pressure mottling, also known as pressure marking or imprinting, is an uneven or irregular gloss pattern on the face of a coil sheet. It is generally caused by disparity in the gloss between the top and bottom surfaces of a coil. These gloss differences are then transferred with time and pressure to either surface causing the irregular pattern. Figure 1 shows two examples of pressure mottling.

- Major gloss difference between the top coat and the back coat
- Surface difference between the topcoat and the back coat as it relates to the glass transition temperature of the polymers used
- Differences in cross-linking densities between the topcoat and the back coat.
- High rewind tension
- Temperature (Coil wrapped too hot, wet, or subjected to conditions that allow condensation in the coil, etc.).

To eliminate pressure mottling that already exists, the strip may be heated. This works because the appearance is normally a flattening or changing of the smoothness of the coating surface. A small amount of applied heat allows the coating to expand to a stable condition, thereby eliminating the characteristic appearance of pressure mottling. Typically the heat generated during the forming process is usually sufficient. In all but the most severe cases, the coating will "recover" (expand) within a few days after the "pressure" is removed.

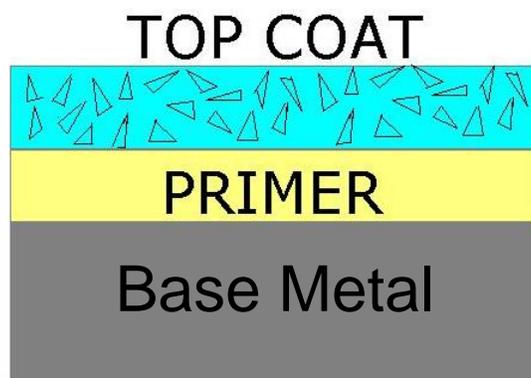
Figure 2

Sample crossview showing gloss components in normal suspension

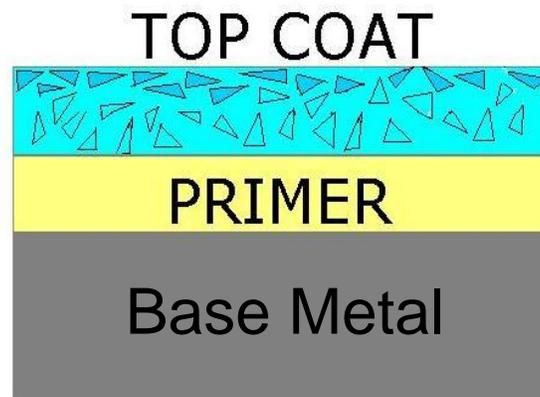
Figure 3

Figures 2 and 3 illustrate how pressure mottling occurs. The gloss components in Figure 2 are under normal suspension within the topcoat and the direction is random throughout. When pressure mottling takes place, the gloss components are suppressed or flattened within the topcoat as seen in Figure 3. Only the components closest to the surface are affected, and this results in the variance in gloss across the strip.

Sample crossview showing "suppressed" gloss components
